RAILWAY INVESTIGATION REPORT

R99T0031

DERAILMENT

CANADIAN NATIONAL
TRAIN NO. CN M-304-41-05
MILE 255.1, RUEL SUBDIVISION
NESWABIN, ONTARIO
06 FEBRUARY 1999

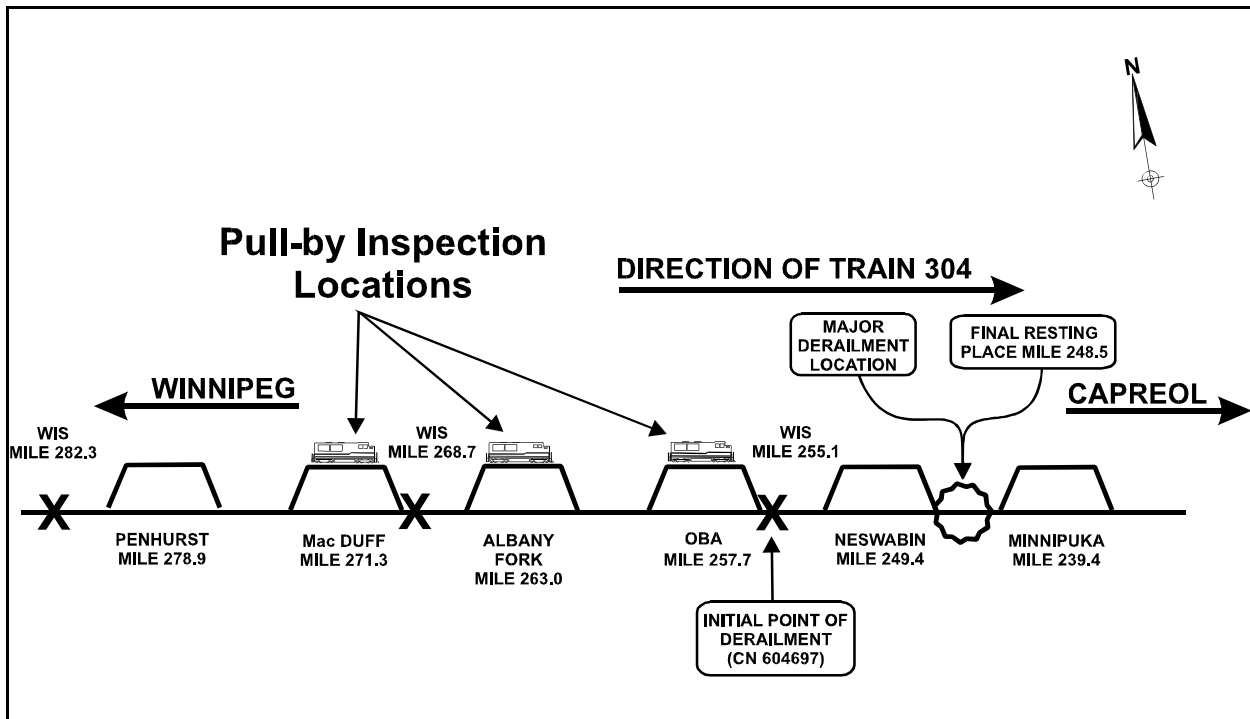
Between the initial terminal of Hornepayne and the point of derailment, a distance of approximately 41 miles, train 304 had been inspected by the crew members of three other trains that were passed at the three sidings preceding the point of derailment (see Figure 5). Train 304 was inspected on the north side only at these three locations. Due to heavy snow conditions, there were few safe areas for employees to position themselves to inspect a passing train on the south side. No defects were noted during these inspections.

Figure 5 - Simplified sketch showing pull-by inspection and WIS locations relative to the accident location (Note: not to scale)

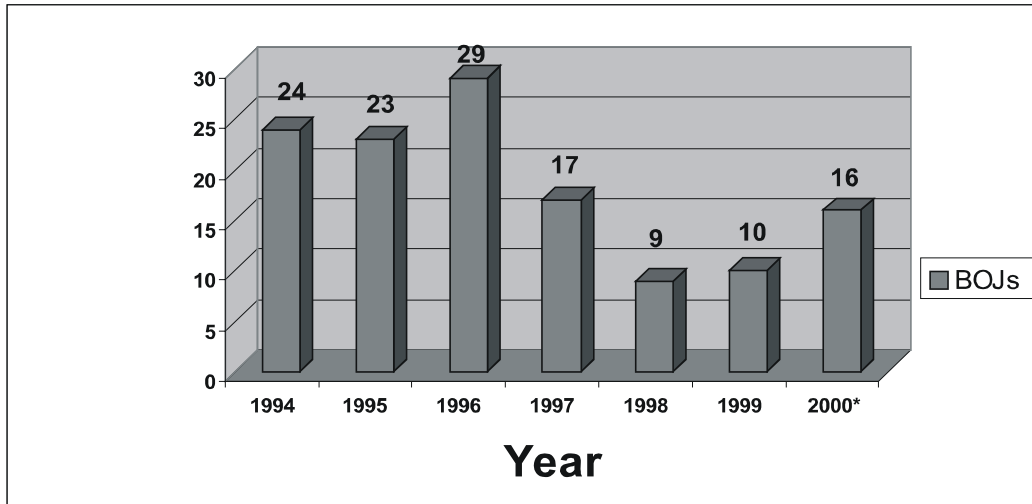
A BOJ normally results in the derailment of the car on which it occurs. Should axle failure happen while the train is proceeding at a high speed, the derailment frequently results in multiple cars derailed and/or damaged. Figure 11 shows the total number of BOJs since 1994 provided to the TSB during the investigation by the three Class 1 Canadian railways.

Figure 11 - Number of burnt-off journals (1994-2000*) on Class 1 Canadian railways (*for year 2000, data represent six months for CPR and ten months for CN)

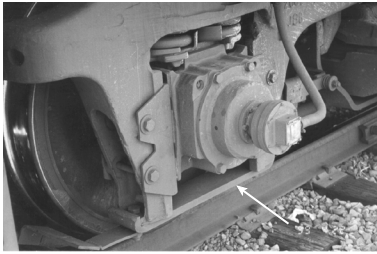
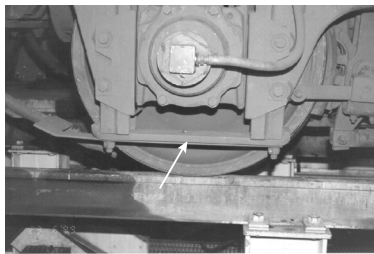
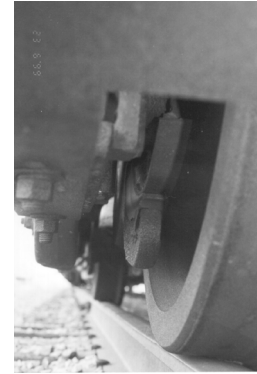
Both Southern Technologies Corporation (STC)¹³ and Harmon Industries¹⁴, the two major suppliers of HBDs in North America, stated that, even in favourable environmental conditions, some bearings on locomotives cannot be accurately scanned. The HBD functions as intended; however, there are mechanical parts located between the bearing and the scanner which can obscure the view of the bearing as it passes the HBD (see Figures 16 and 17). These mechanical parts differ by axle size and by locomotive type. Locomotives represent a small percentage of all axles scanned; however, unlike freight equipment, many locomotives are manned.

Figure 16 - Side views of locomotive roller bearing housing
(Note: bottom tie strap under bearing)

Figure 17 - End view of roller bearing housing on railiner
